ANALYSIS OF PITTING AND CREVICE CORROSION ON INCOLOY 825-CLADDED CARBON STEEL PIPELINE IN AERATED STAGNANT WATER

Hussein Mesmari 1; Esra Gajam 2; Fatma El Zrarog 3, Department of Materials and Metallurgical Engineering, Faculty of Engineering, University of Tripoli-Libya

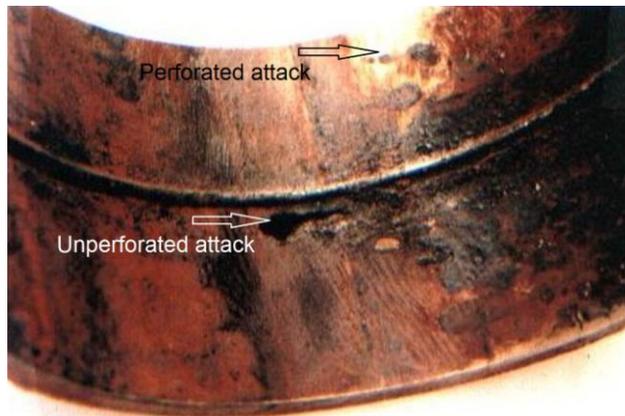
inspected and all observations, remarks, and the required tests are reported and considered for further work and analysis. Figure 3 shows the internal surface of the pipe and the perforated location and, pitting corrosion nucleation and growth next to the weld line root.

Figure 3. as received portion of the failed pipe.

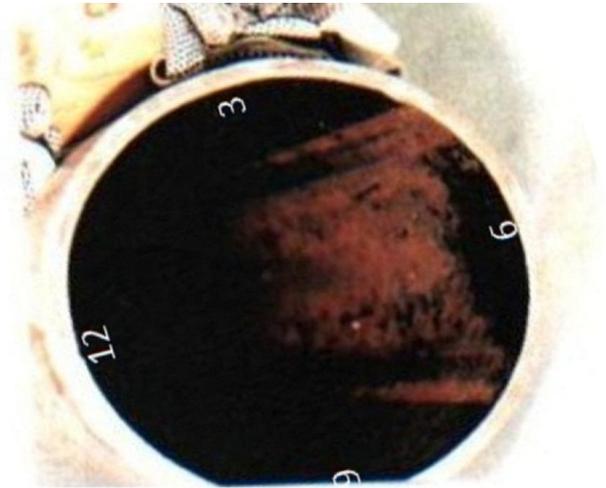
- 1- The failed section of the pipe had a clear mark of water accumulation at the bottom of the line (between the 4 and 8 o'clock positions) as in Figure 4.
- 2- The perforation and leak occurred within the water marked area. The leak was in area close to HAZ of the circumferential weld as shown in Figures 3 and 5.
- 3- The pipeline was seamless made of carbon steel as the base material, and clad with Incoloy 825 and welded with Inconel 625, all pipe joints are butt welded.
- 4- The pipeline was suffering from accumulation of stagnant water for a time period more than six months.
- 5- Dimension measurements indicated that thickness of cladding is 3 mm and the base metal thickness is 8 mm, i.e, the total pipe thickness is 11 mm.

Figure 4. Indication of watermark on the internal surface

5- In such condition, the line should be immediately drained of formation water and flushed out with inhibited fresh water to prevent further corrosion or deterioration of the lining material. Also a strict quality requirements, and auditing should be imposed.

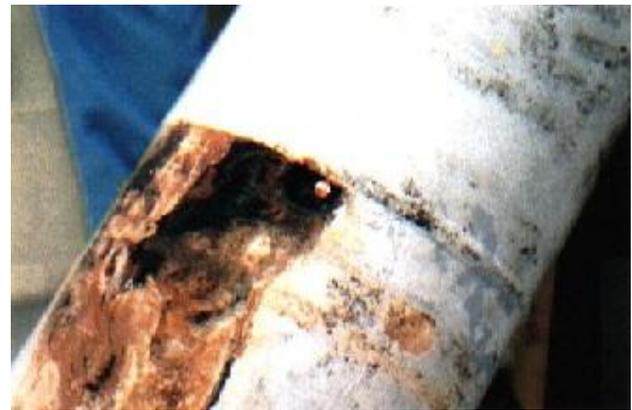
Figure 5. Perforation as appeared on external surface of pipe.

3-- Under deposit, the pit formation starts the pitting corrosion, caused by the accumulated sludge inside the unoperated aerated pipeline. Perforation is mainly attributed to crevice corrosion under clad-base metal interface, then followed by general corrosion to outer surface.

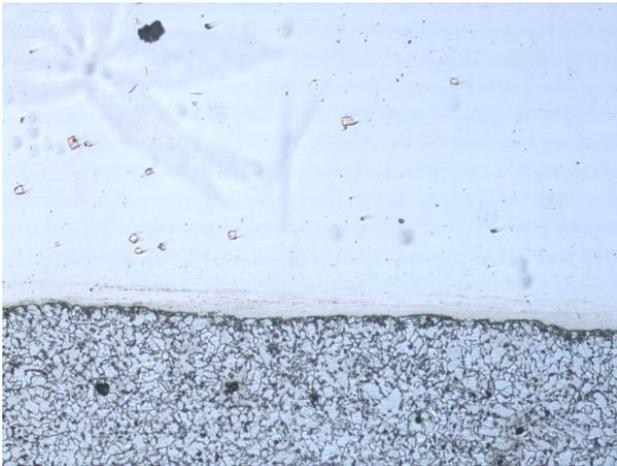
Fig.6-a, CM with TiC, narrow band & base metal

As can be observed after 2% Nital etching (figs. 6a & c), the cladding line follows the profile of the Ferritic and pearlitic grains of BM, a narrow band parallel to the original interface has been formed in the wake of hot cladding process. This band separates the base steel from the single austenitic (fcc γ) phase of CM. metallurgical bonding gives inter diffusion of elements such as carbon to diffuse in the austenitic clad metal, that leads to metallic carbide precipitation. Regarding to the high Ni and Cr contents, the solubility of carbon is low and abundant Cr carbide precipitation takes place mainly on twins and grain boundaries. The Presence of corrosion spots in forms of reduction in wall thickness all over the CM can be attributed to galvanic action between the parent CM incoloy 825 (Anode) and the CWM Inconel 625 (Cathode) after exposure to the highly saline formation water. The pitting defects present at CM surface away from the HAZ is more likely to be occurred underneath the water scale buildup in which the formation water inside the pipe has a positive high scaling tendency, specially under the water stagnant condition of high chloride contents, where the scale can play a role of cathode with respect to the CM which acts as an anode. The radiographic results clearly indicates the defects shown are not within the

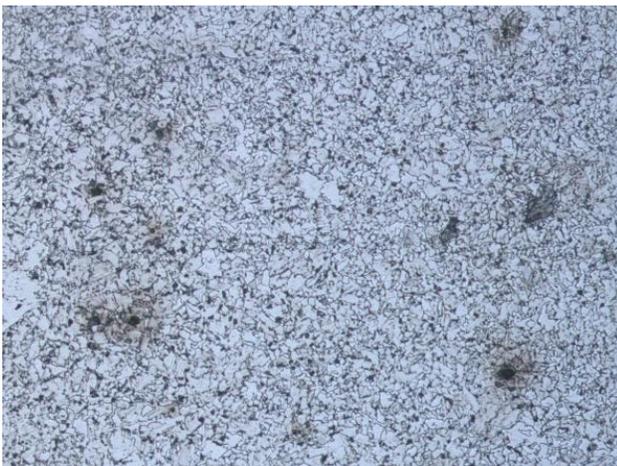
Fig.6-b, hypotectoid structure of base metal

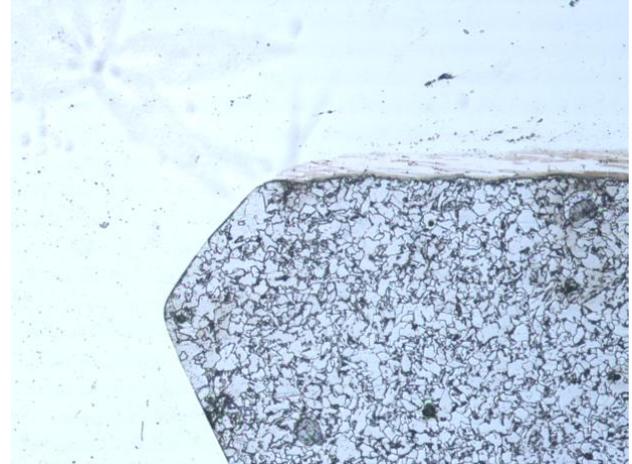
Fig.6-c, the interface lines between base metal-CWM, & base metal-CM

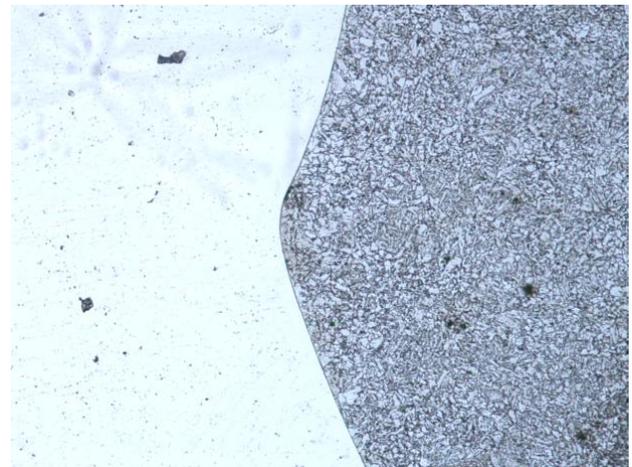
Fig.6-d, solid line interface base metal- CWM

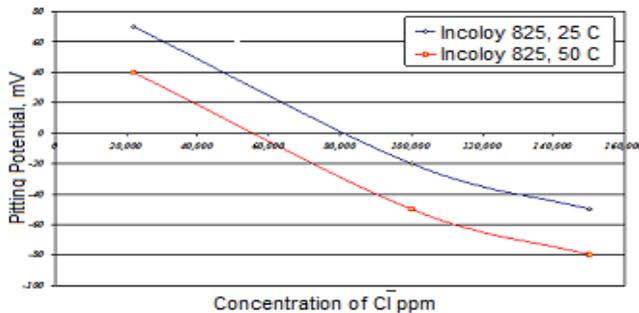
The effect of test temperature on pitting potential of both CM, and CWM is obvious especially for CWM, after being tested in various concentrations of chloride ions. It can be observed that, the increase of test temperature from RT to 50°C caused a marked reduction in E_{pit} for CM, Which found to be more depend on the concentration of chlorine ions (Cl^-). In other hand, CWM shows a gradual decrease in E_{pit} as concentration of chlorine ions (Cl^-) with considerable effect of test temperature. All that effect is clearly shown in table 4, and at the comparing figures (7 a & b).

Fig.7-a Effect of Cl⁻ concentration & Tep. on E_{pit} of CM.

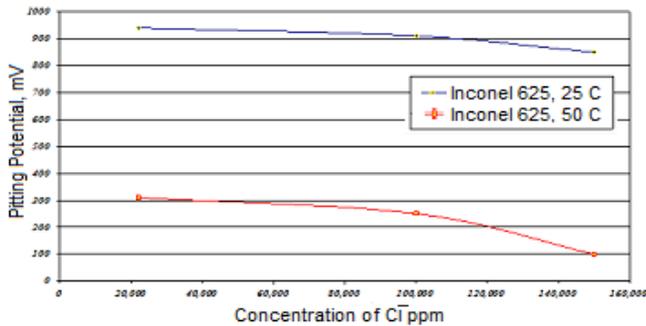
Fig.7-b Effect of Cl⁻ concentration & Tep. on E_{pit} of CWM
